FORTRESS STABILIZATION SYSTEM IN ACTION

CARBON FIBER COUNTERSUNK STAPLE

THE BEST FOUNDATION CRACK REPAIR AND STABILIZATION SYSTEM

FIX CRACKED CONCRETE PERMANENTLY!

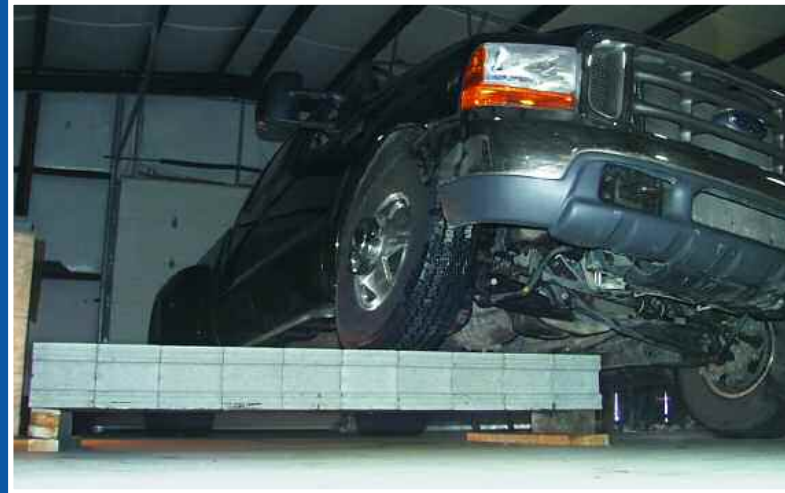
TEST 1-08.01

PROOF: 10 cement blocks held together with only one Fortress carbon fiber strip (on bottom side only).

Ford F-350 Extended Cab ramped up onto a row of cement blocks. There is no mortar between the blocks—only one strip of carbon fiber on lower side. This is a serious and accurate demonstration of the amazing strength of carbon fiber.

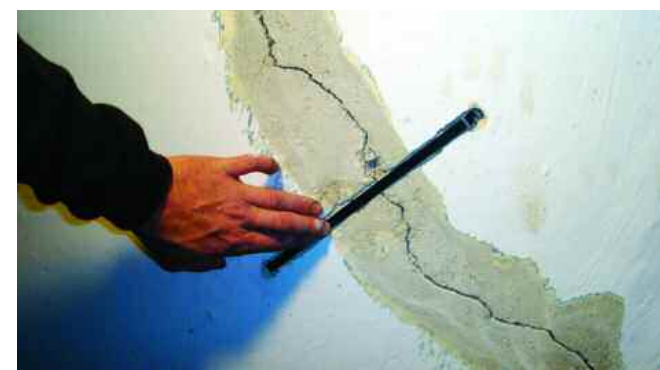
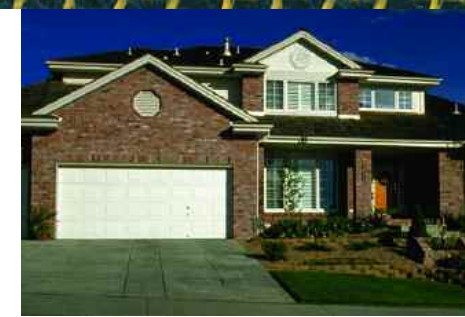
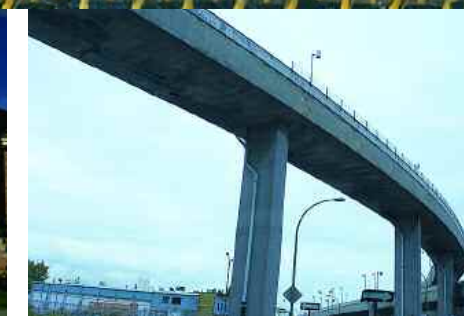
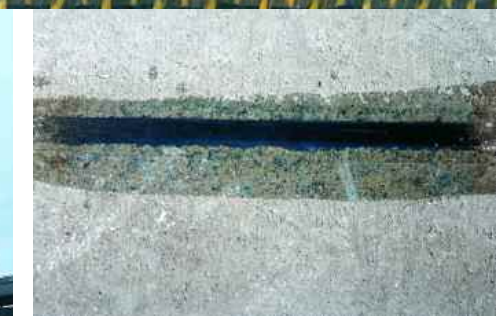
6 directions of wall movement

Closing thermal changes

Opening thermal changes

Uneven loading & settling of footing

Soil shrinkage

Soil pressure

The 6th direction of movements is a combination of all the other 5 wall movements.

Understanding this Fortress Stabilization has researched, developed and patented a unique carbon fiber countersunk staple that will help stabilize the wall in all 6 directions of movement.

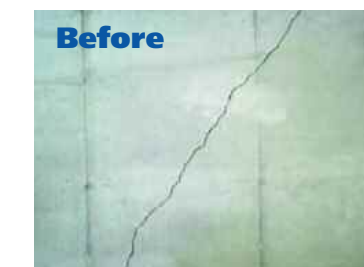
Before

Pictures to the left is a typical foundation crack. Below is after Fortress Stabilization carbon fiber countersunk staples are installed and the wall is ready to be painted.

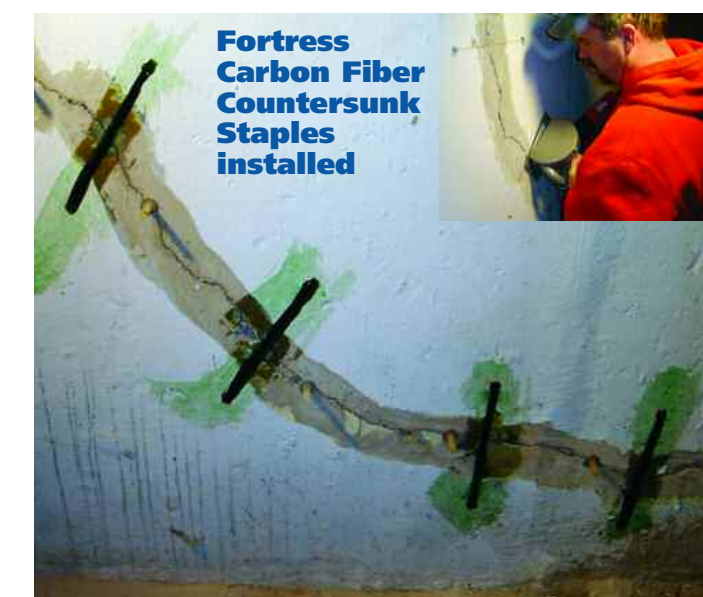
Fortress Carbon Fiber Countersunk Staples installed
